Preventing Molten Metal Explosions in Smelters

Alex Lowery

Wise Chem, New Albany, United States of America

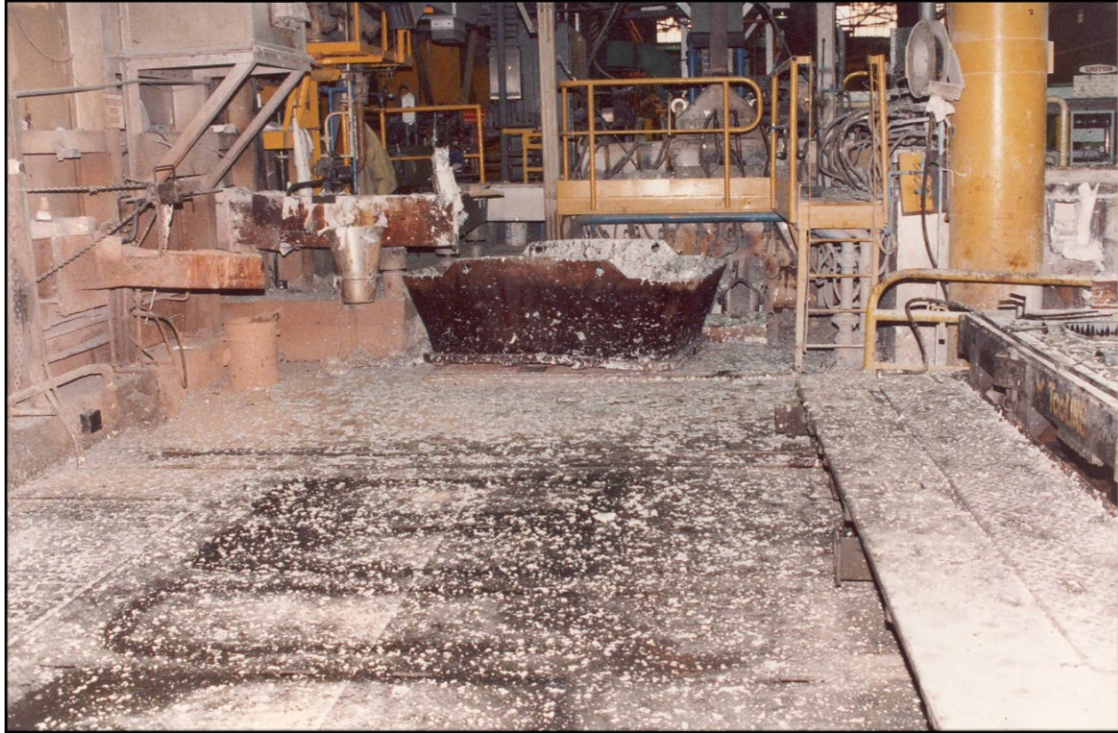
Figure 1. Common physical reaction explosion involving a drain pan.

When molten metal covers water in a physical reaction, the water molecules expand as it turns from a liquid to a vapor. Water expands by a factor of 1 600 when it turns into steam [2]. "It expands because the bonds holding water molecules to each other are broken in the transition from water to steam, and the steam behaves like a gas -- it takes up much more space." This rapid expansion results in the molten metal being propelled away in distances as great as 30 meters. A fire or injury or death can occur when the molten metal lands on a combustible material (e.g., cardboard, wood, etc.) or on a worker. In a physical reaction the mass of the metal remains unchanged after the explosion. For example, if 500 kg of molten metal explodes afterwards there is 500 kg of solidified metal spread around the workplace. Physical reactions are common with all types of metals, aluminium, iron, bronze, steel, etc.

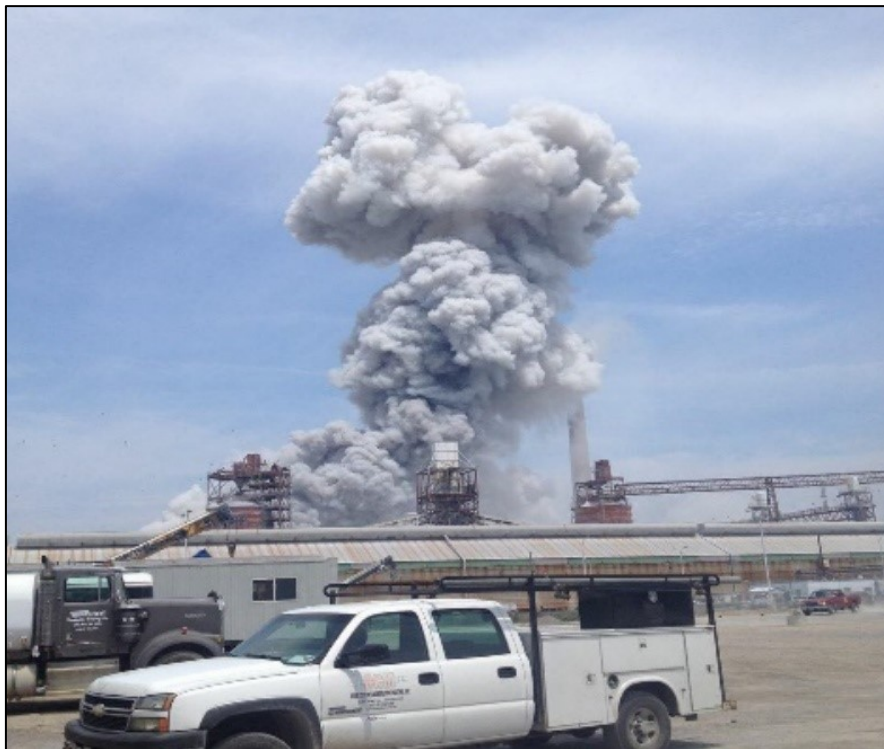
Figure 2. Aluminium oxide mushroom cloud from 2016 Noranda Aluminum chemical reaction explosion in the USA.

As stated before, in a physical reaction the mass of aluminium after an explosion does not change. But, in a chemical reaction the mass of the aluminium is turned into aluminium oxide and energy. The aluminium oxide in the form of powder commonly billows up in a mushroom like cloud from the workplaces is common in chemical reaction explosions.

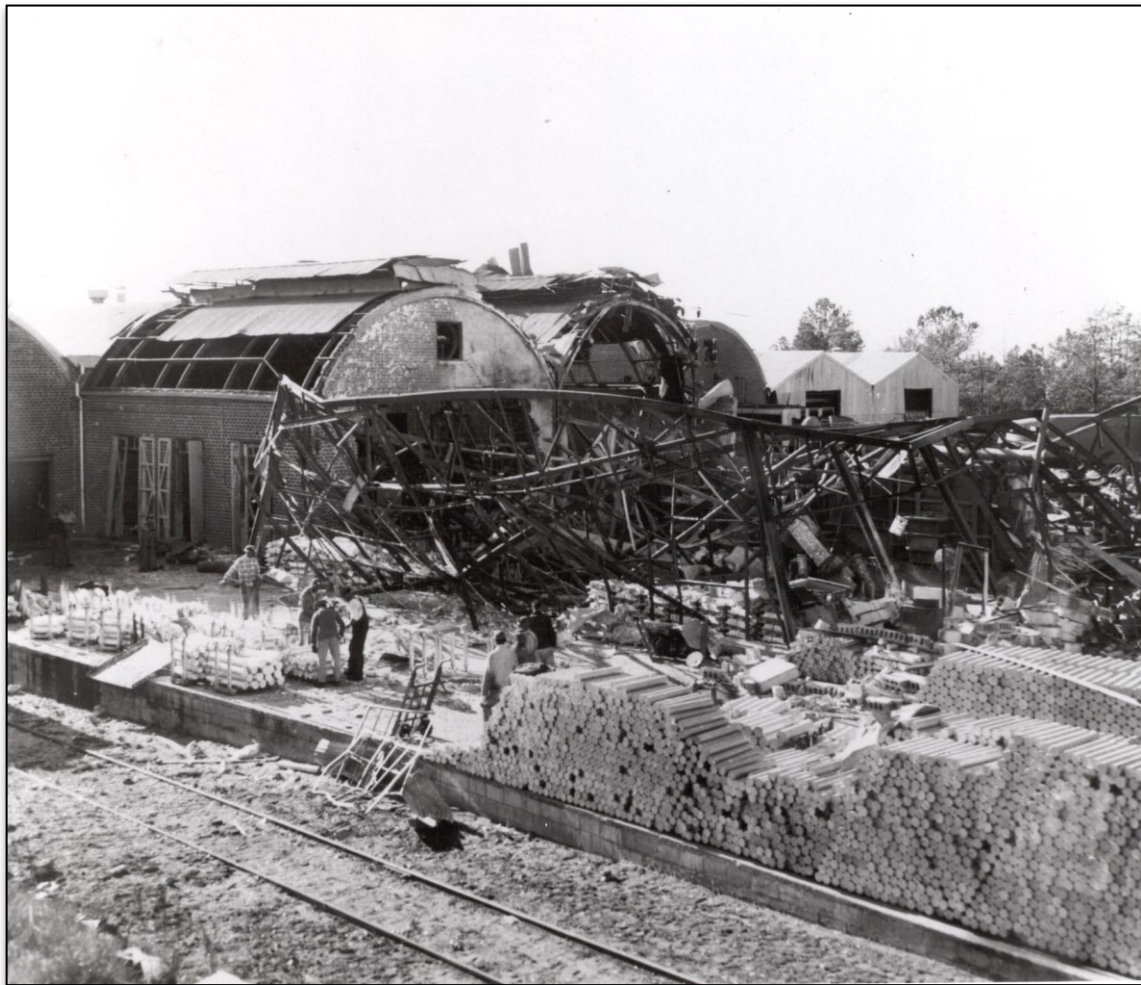
Figure 3. 1957 Georgia, United States.

One of the earliest photos of explosions that this author has is from Georgia, United States in 1956. Three workers were killed and twelve others were injured. The force of the explosion broke trees two kilometers from the workplace. The company owner was quoted by a local newspaper afterwards that “the blast was caused by the dumping of wet scrap aluminum into melting pots containing molten metal” [5].

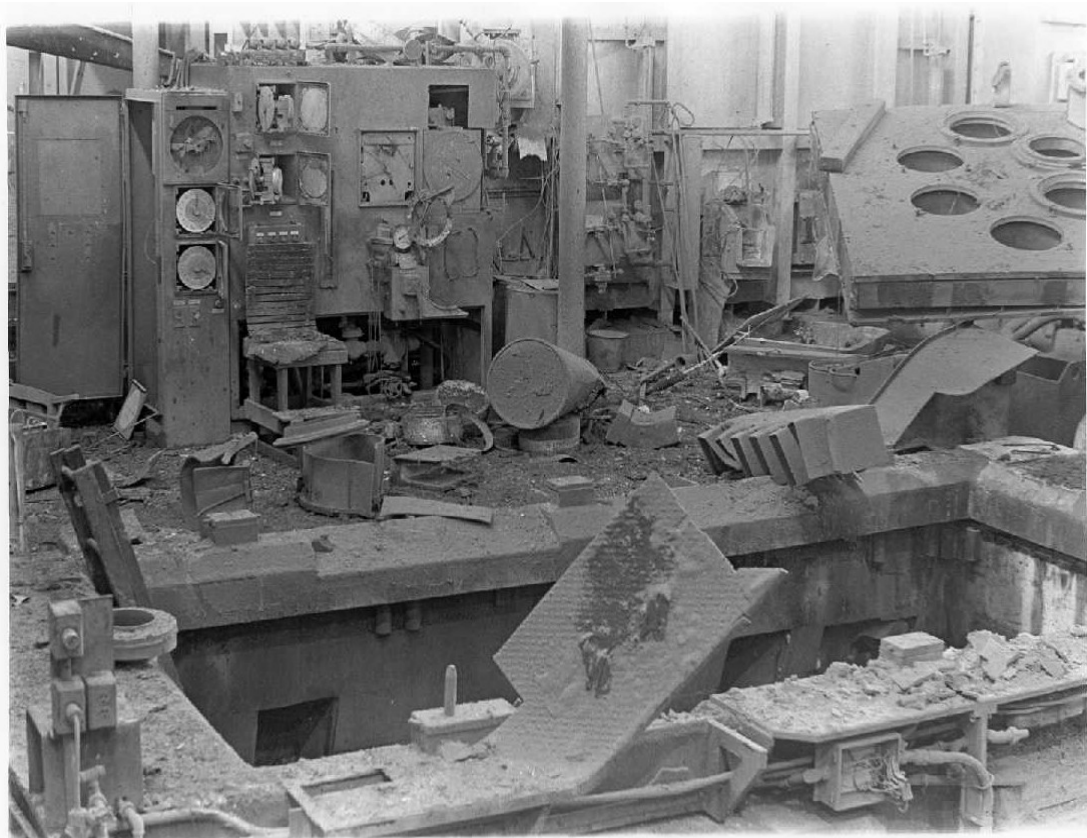
Figure 4. October 8, 1975, Explosion that occurred due to starting head base not bolted down on one end.

On October 8, 1975, an explosion at a billet casting station killed one worker and injured another in the USA. It was determined that two out of four bolts holding the casting station’s starting head base (aka bottom block or doghouse) to the platen was left off. There was a metal hang up in the casting table during casting. The casting cylinder descended pulling the platen and starting head base down. However, because there was a metal hangup, one or more billets were stuck to the mould on the casting table. Normally, the rectangular shaped starting head base is secured with four bolts, one on each corner. But, on this day, maintenance personnel only secured one end with only two bolts started to lift up. As the platen descended the end of starting head base not secured began to raise. Eventually, the stuck billets let loose resulting in the starting head base slamming down onto the platen resulting in an explosion.

The aluminium company theorized the force of the starting head base hitting the platen resulted in a shockwave traveling through the molten metal triggering an explosion. The company told others in the industry about the severity of the explosion and their theory on how the explosion occurred. Which resulted in research investigating the impact shockwaves have upon generating molten metal explosions.

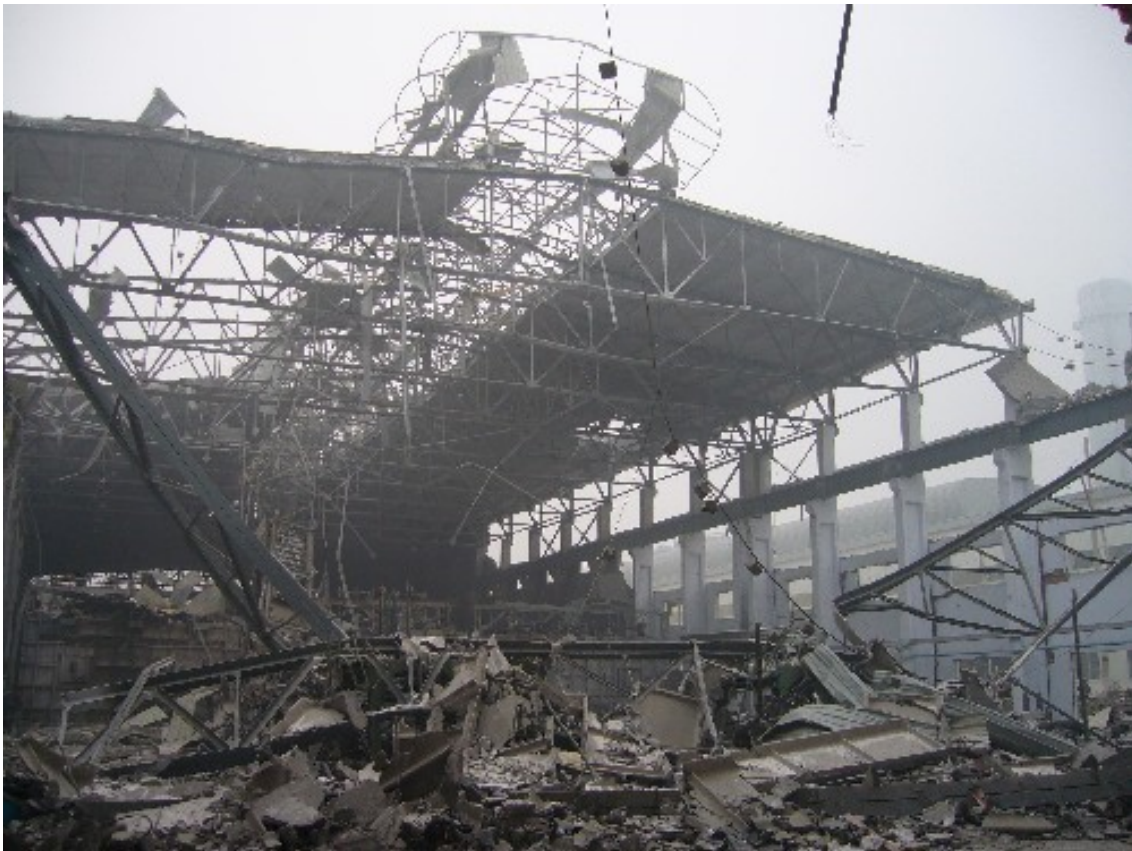
Figure 5. August 19, 2007, Explosion occurred when furnace lining failed and contents emptied into casting pit.

An explosion occurred on August 19, 2007, in the aluminum busbar casting branch of an aluminium company in Asia. The governmental investigative report after the explosion stated “During the shift production, the inner sleeve of the furnace hole brick (made of silicon carbide) was missing (whether it fell off or broken, because all the insiders on the scene were killed in the accident, and the site repeatedly searched for the inner sleeve of the furnace brick without success, and it is difficult to judge the true state of the inner sleeve before the accident), resulting in the furnace hole becoming larger and the molten aluminum out of control, a large amount of high-temperature molten aluminum overflowed into the chute and flowed into the circulating cooling water return pit on the south side of the distributor of the No. 1 16-tonne ordinary aluminum ingot casting machine, in a relatively confined space. The molten aluminum reacts with water and at the same time produces a large amount of steam, the pressure rises sharply, and the energy gathers and explodes.” [12]. The explosion destroyed the casthouse resulting in 16 deaths

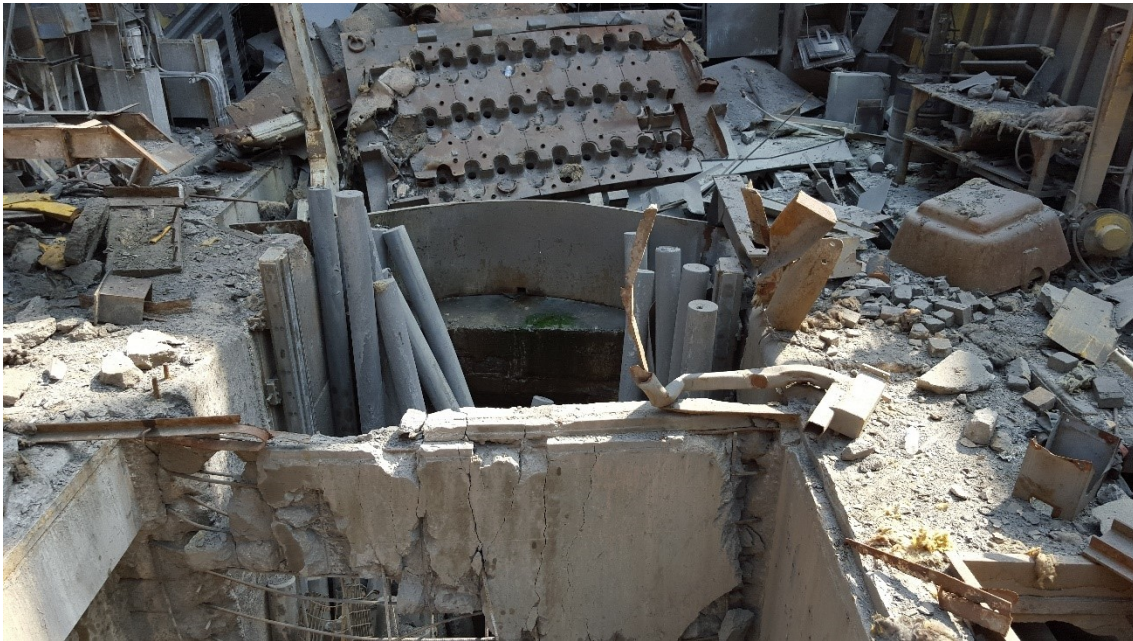
Figure 6. August 4, 2015, Noranda Aluminum explosion.

On August 4, 2015, explosions were reported at the Noranda Aluminum casthouse in New Madrid, Missouri, USA. The U.S. Department of Labor's Occupational Safety and Health Administration (OSHA) said the cause of the explosions appeared to be the failure of a furnace lining and the leaking of the molten aluminum contacting water in the vent pipe of the direct chill casting pit. Thirty-three employees were injured in the explosions, most suffering eye and throat irritation and ringing of the ears. One worker, an overhead crane operator, injured his back descending an emergency ladder after the explosion knocked the power out to the building.

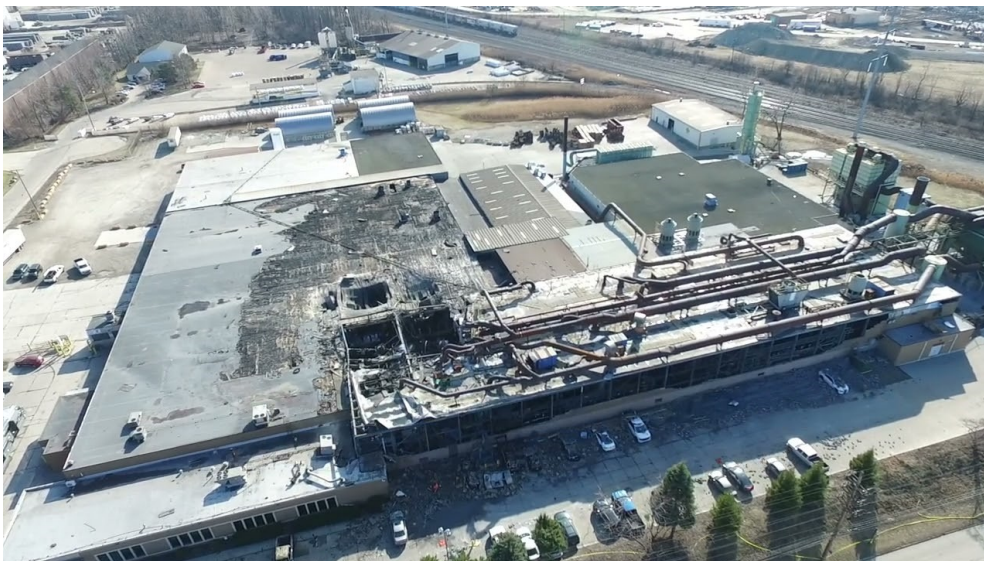
Figure 9. February 20, 2022, Cleveland, Ohio, USA foundry explosion.

This is a very dangerous condition commonly resulting in an explosion. This occurred on February 20, 2022, at a foundry in Cleveland, Ohio in the USA. The explosion destroyed the foundry, initially killing one worker and injuring fifteen workers. "What happened was a massive amount of water got into the furnace, and then it somehow got under mixed in with molten metal trap and created a massive explosion," said Howie Eberts, Area Director, OSHA's Cleveland Office [13].

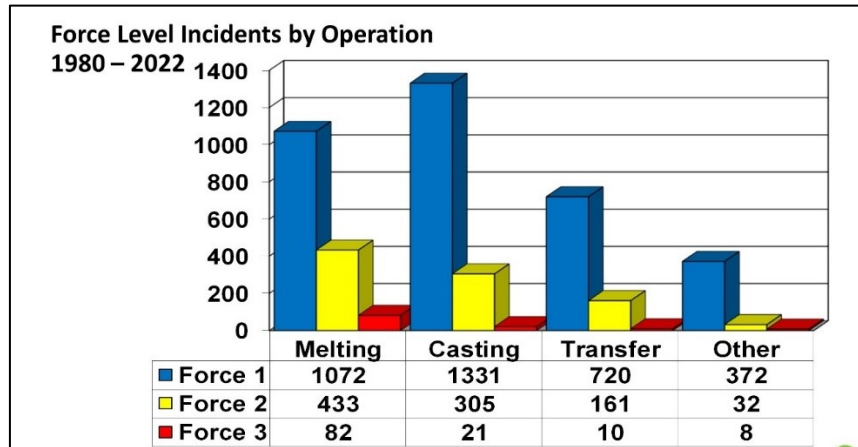
Figure 10. Force Level Incidents by Operation for 1980-2022, September 2023.

Molten aluminium incidents commonly happen in two departments in a smelter: potline or the casthouse. Incidents have also been reported during the transportation between those two departments. The Aluminium Association's Molten Metal Incident Reporting Program (MMIR) annual report is a useful reference for determining the most common tasks/procedure or localized areas where an incident can occur.

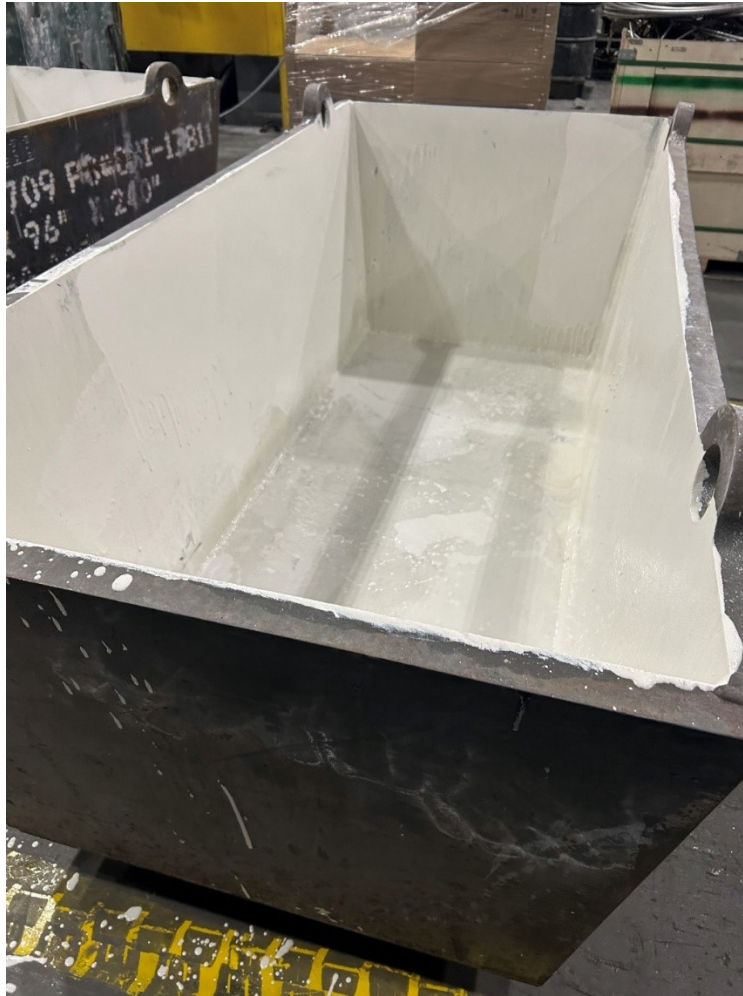
Figure 11. Emergency drain pan coated with Wise Chem E-115.

A growing number of companies have applied Wise Chem E-212-F or E-115 to their emergency drain pans, ensuring they will be ready for use and there is no need to be oiled.

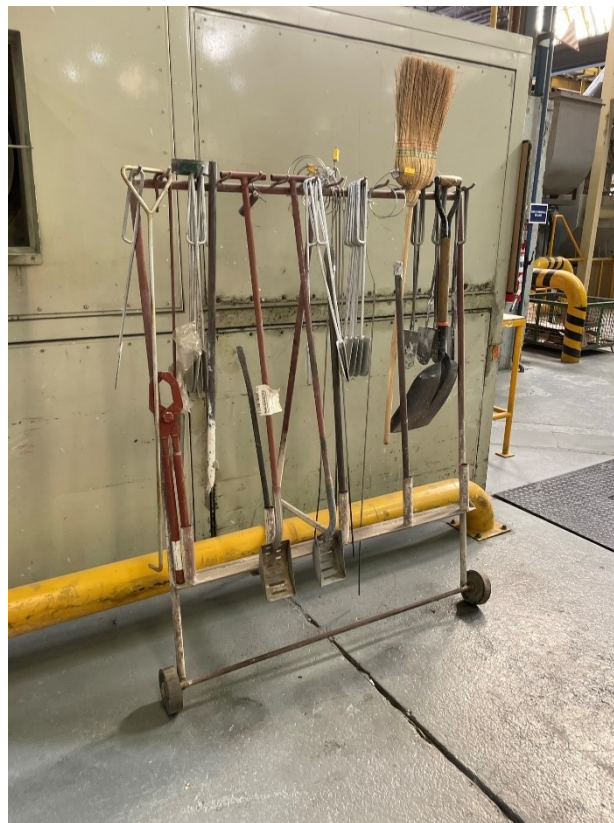
Figure 12. Example of how to properly store molten metal hand tools.

All tools furnace and hand should be stored indoors and away from any open doors. This will minimize any moisture from the outside weather (e.g., rain, snow, dew) landing on them. Some workplaces install hand tool storage next to furnaces to assist in keeping the tools warm and free of moisture.

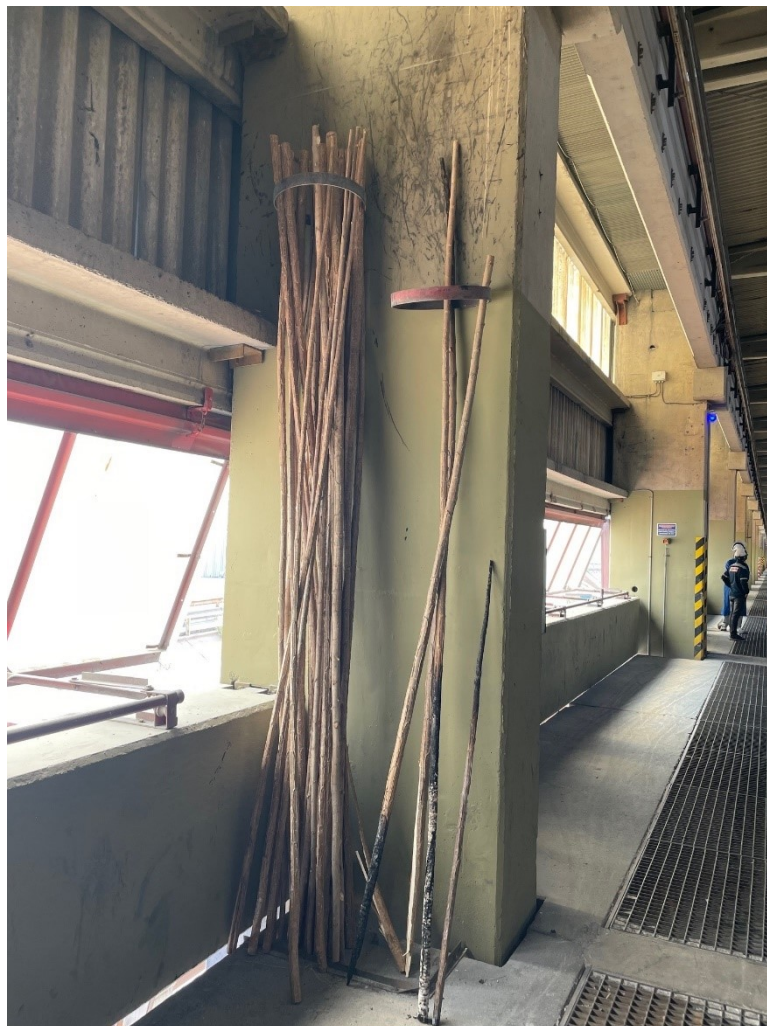
Figure 13. Green wood sticks storage.

Another contributing factor to molten metal incidents in the potline department is one specific tool, green wood sticks. The “green” means that these sticks are typically fresh from cutting and have some internal moisture in them. These sticks are used by workers to kill anode effects in the pots, causing bubbling that helps eliminate gases below the anodes and dissolve alumina from the anode cover.

Green wood sticks vary in type from some tree saplings to bamboo. Typically, 3-4 meters in length to allow the worker to stand away from the pot while using the green stick to penetrate the bath. As can be seen in the photo, green sticks combust and ignite. Overtime the length of the green stick will decrease. This can become a hazard because the worker now has to lean or place their body over the bath to perform the task at hand. Workplaces should have a minimum length of green sticks to be safely used. Green sticks should be discarded when they are shorter than the minimum length.

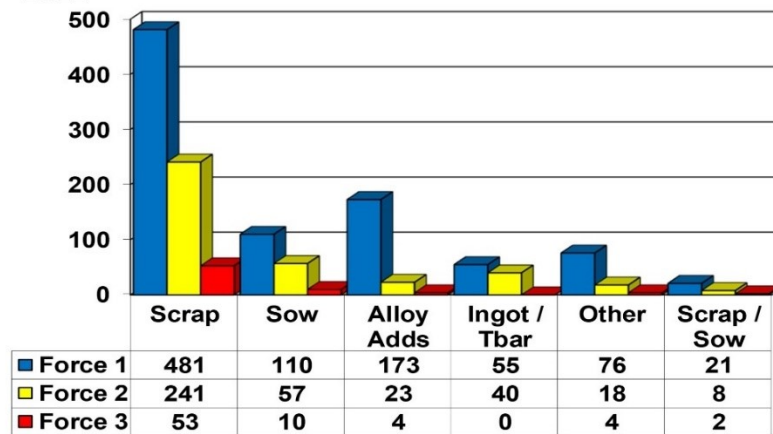
**Melting Explosions – Charge Material Involved
1980 – 2022**

Figure 15. Melting Explosions by Charge Material 1980-2022, September 2023.

Every smelter is studying how to incorporate scrap into their processes to reduce their carbon footprint. The addition of scrap opens a new chapter in molten metal safety in smelters. Whereas remelt facilities have learned over time the numerous dangers associated with scrap. Smelters lack the knowledge and awareness to this hazard. In 2022, over 47 incidents generated from scrap were reported to the MMIR.

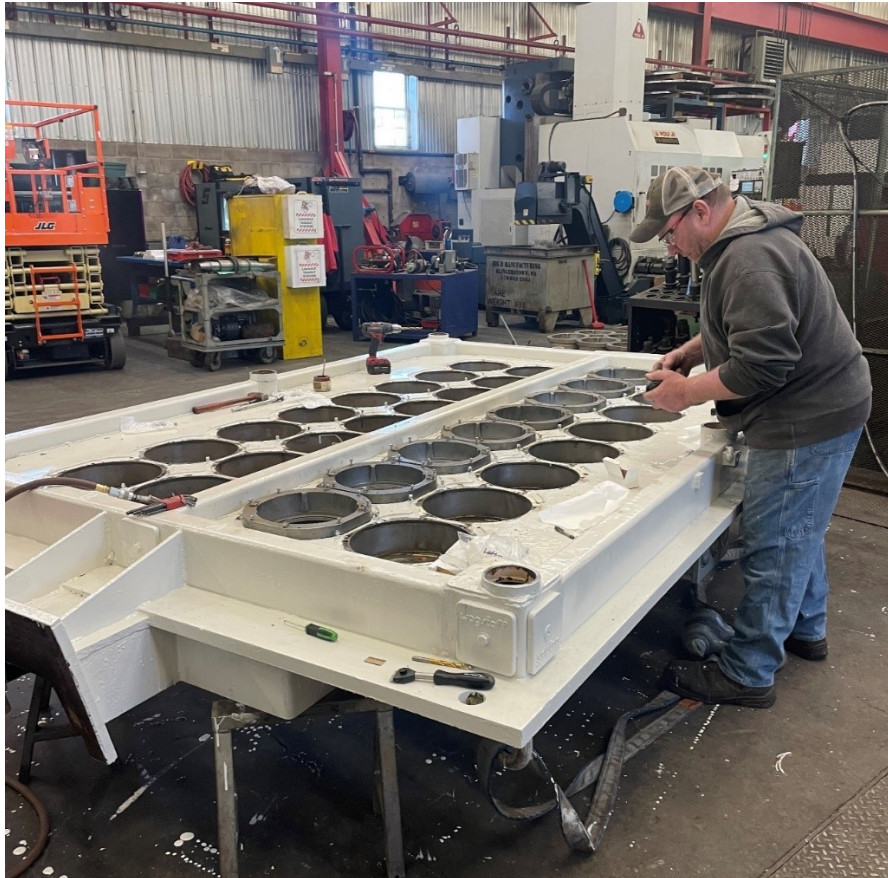
Figure 16. Wise Chem E-212-F coated on a vertical direct chill casting table.

The Aluminum Association's "*Guidelines for Handling Molten Aluminum, Fourth Edition, May 2016*" [6] list Wise Chem E-212-F and E-115 as "*identified as having the ability to prevent explosions from bleedouts into the pit during casting*". For example, in a casthouse the pit walls and bottom under the vertical direct chill casting machine should be coated with Wise Chem. The maintenance pit adjacent to the casting pit as well as the maintenance pit under any furnaces should be coated with Wise Chem. All steel and stainless tooling should be coated with Wise Chem to prevent an explosion from arising. The floors and walls where crucibles are filled should be coated with Wise Chem.

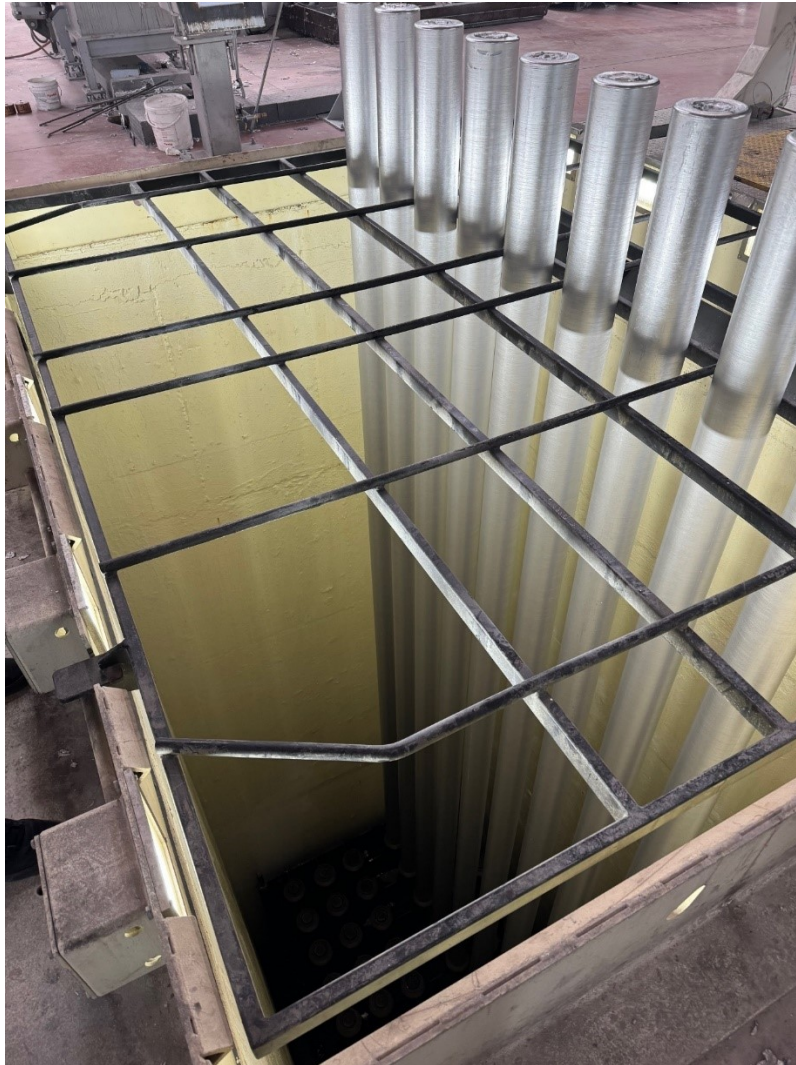
Figure 17. Wise Chem E-212-F coating casting pit.

Maintenance of the Wise Chem coatings is very important in preventing explosions. Scientists have theorized that Wise Chem prevents explosions by releasing gases when contacted with molten metal. A gas release pierces through the molten metal allowing for any trapped moisture to escape and not generate an explosion. Overtime and through repeated molten metal exposure Wise Chem coatings wear away exposing the bare substrate below. Wise Chem coatings must be applied directly on a substrate and no primer should ever be used. There are 50 years of scientific studies on Wise Chem preventing molten metal explosions. None of these studies had a primer underneath during any of the testing.
